Risk Control Engineering's regular ongoing bulleting on construction, fire protection, equipment hazards and all things risk management.

POLYBUTYLENE PIPING SYSTEMS (POLY-B)

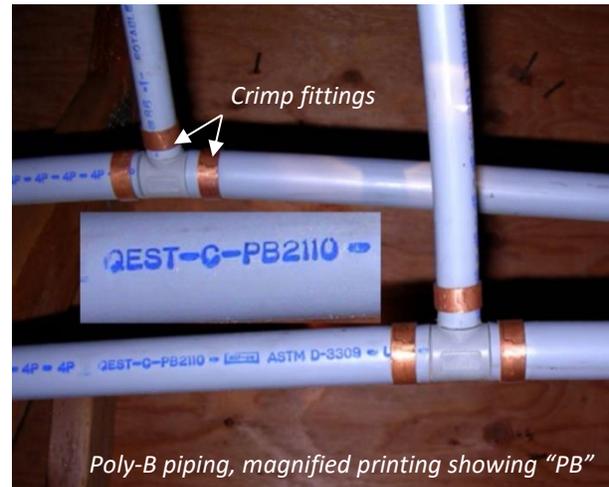
Polybutylene piping, commonly abbreviated as Poly-B, was a common domestic piping material employed in cold and hot water applications. It is identifiable by the light grey-blue color of the piping (common to many brands) as well as the copper or plastic "crimp" fittings that are used to assemble it. In addition, the piping will be marked with material listings codes and will usually include the letters "PB" in the printed string. Both are shown in the image to the right.

The other common failure mode in the piping relates to the crimp connectors shown above. Many of the connection components in the system were thin wall plastic pieces and the over-crimping (or tightening) of the connection rings by installers created micro-cracking. This lead inevitably to failure at these connections. Both failure modes are relatively problematic for home owners and inspectors as nearly all piping is hidden within walls or enclosed spaces and is not available for inspection.

Buildings with Poly-B piping can try to slow degradation of pipes and lower likelihood of failures in existing system by reducing temperature and pressure. Owners of Poly-B systems should operate their plumbing at reduced pressures (below 60 psi) and reduced temperatures (55-60°C). This can help slow the

degradation of the piping, but cannot avoid inevitable failure. Re-piping of the water system with chemically stable material such as cross-lined polyethylene (PEX) is considered the only permanent fix for this exposure.
