Headline: **Corrosion of Copper Water Pipe in the Lower Mainland Common Property Requires Mutual Responsibility – Be Informed**

Publication date: June 2004

Publication: CHOA Journal

Written by: John Davidson, P.Eng., Levelton Consultants Ltd.

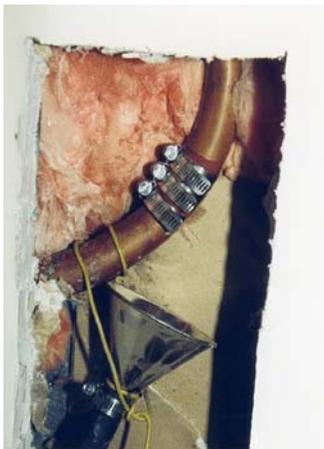
Fig 1 – Rubber hose clamped on a leaking cold bend in copper pipe (tubing). The leak was so pervasive that a funnel was installed to remove the water drip. This is not long-term management of copper tube corrosion.

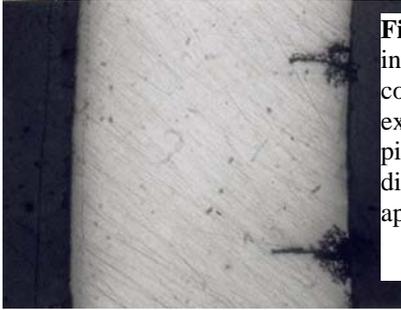
Fig 2 – Copper pipe wall in section. Typical corrosion fatigue cracks extending from corrosion pits on the internal diameter. Magnification approximately 65 X.

Corrosion-fatigue is a phenomenon whereby cracks in the copper tubes propagate because of cyclic loading. This progressive fissuring is dramatically accelerated by the simultaneous activity of corrosion. Corrosion-fatigue is a very common problem in recirculating hot water systems due to the heating and cooling (expansion and contraction) combined with:

All of the above factors can contribute to repeated movement, most commonly due to the expansion and hence elongation of tubing when it warms while transmitting hot water. If the expansion/elongation is not accommodated or restrained, flexure about elbows in the pipe advance cracks through the pipe wall.

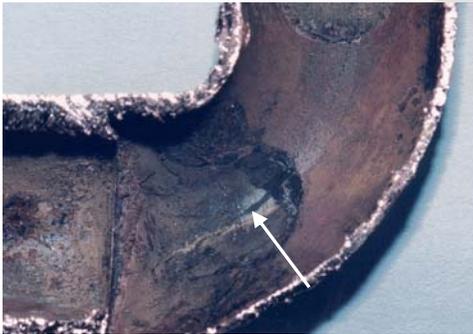
Fig 3 – Close-up view of crack (see arrow) which initiated in residual flux puddle.

The use of excessive flux must be avoided in the course of installation. Soldering flux is a chemically active, corrosive substance utilized to promote wetting of the surface to be joined with solder. Excessive flux typically results in puddles, runs or deposits on the inside of the tubing and promotes an undesirable chemically active surface where corrosion and pitting initiate.
